**Flood Control Project Maintenance
Levee Inspections**

Fall 2016 Levee Maintenance Deficiency Summary Report

Sacramento River Basin

NA0001	Overall LMA Rating	Total LMA Miles						
American River Flood Control District	A	34.47						
Rated Item	Maintenance Deficiency				Enforcement		Design & System Obsolescence	
	M Miles	U Miles	M + 4U Miles	Threshold %	M Miles	U Miles	M Miles	U Miles
<i>Earthen Levee</i>								
Vegetation	0.05		0.05	0.15%	0.73	0.38		
Encroachments					1.07	3.34		
Animal Control	0.02		0.02	0.06%				
Slope Stability	0.08		0.08	0.23%				
<i>Supplemental</i>								
2015 USACE Erosion Survey, DRAFT	0.04		0.04	0.12%				
DWR UCIP Field Study					0.96	0.07		
<i>LMA Totals:</i>	0.19	0.00	0.19	0.55%	2.76	3.79	0.00	0.00
Unit No. 01 Arcade Creek LB	Overall Unit Rating	Total Unit Miles						
NA0001	A	2.08						
Rated Item	Maintenance Deficiency				Enforcement		Design & System Obsolescence	
	M Miles	U Miles	M + 4U Miles	Threshold %	M Miles	U Miles	M Miles	U Miles
<i>Earthen Levee</i>								
Vegetation	0.01		0.01	0.48%	0.04	0.03		
Encroachments					0.30	0.27

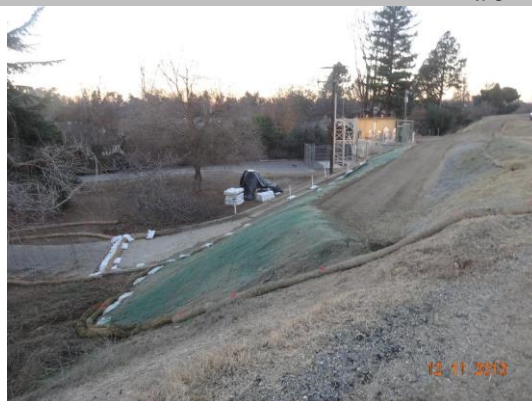
Photo 1 of 2 : UCIP_FA_2016_31446_57490.jpg

LM Start	4.61	Rating **	M	Issue No.	761
LM End	4.61	Issue Type +	En	Location *	LS
Category	Supplemental			GPS Latitude/Longitude	
				Start	End
Item	DWR UCIP Field Study			38.581101 °	38.581101 °
				-121.436502 °	-121.436502 °
DWR ID					
Comment Code					
Inspector Comment					
FS_ID:31446 DS_ID:24808 EP_NO: N/A Repair Type: Non-Urgent Crossing Status: Indicator Found UCIP Comments: New construction--need permit and details on crossing. FIELD_STRUCT_DESC: 1 of 4: Concrete service box located on waterside (WS) shoulder. Landside (LS) has been regraded. No permit was found for the work. Unable to verify if crossing crosses levee. FS Date: 12/13/2013

View of landward side.

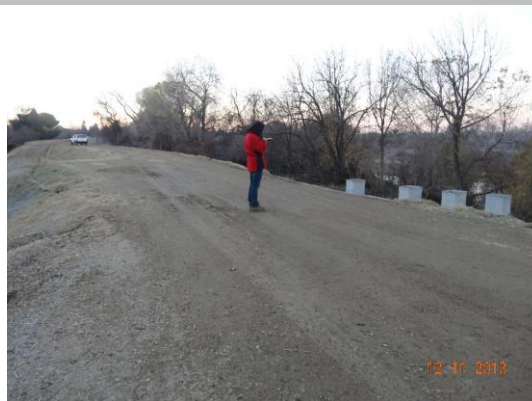
Photo 2 of 2 : UCIP_FA_2016_31446_57489.jpg

View of regraded levee crown with service boxes on waterward slope.

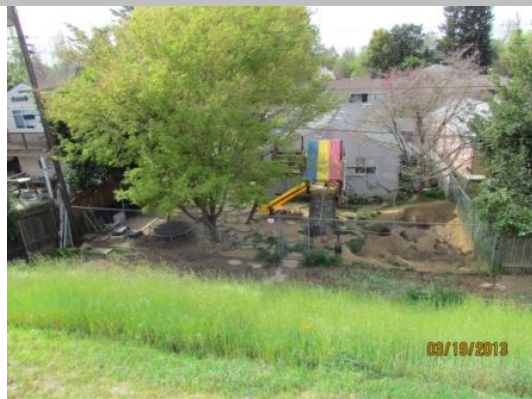
Photo 1 of 2 : FA_2016_NA0001_55_739_20160914_00191.jpg

LM Start	4.72	Rating **	M	Issue No.	739
LM End	4.72	Issue Type +	En	Location *	LS
Category	Earthen Levee			GPS Latitude/Longitude	
				Start	End
Item	Encroachments			38.580778 °	38.580778 °
				-121.434467 °	-121.434467 °
DWR ID	DWR_NA0001_04_f_2016_739				
Comment Code					
DE : Debris					
Inspector Comment					
PVC pipe and debris, also noted in USACE PI.

View of the previously noted debris stored in the upstream corner of the property. Note extensive burrowing in the backyard on the downstream (right) corner of the property.

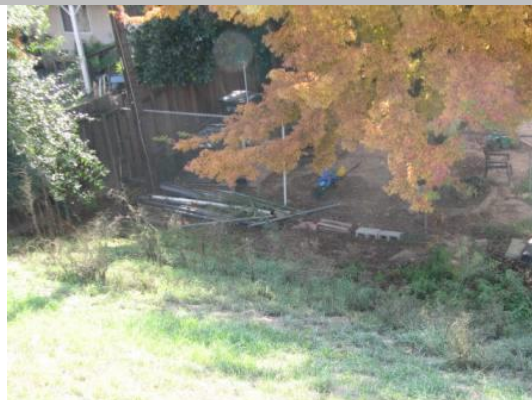
Photo 2 of 2 : FA_2016_NA0001_55_739_20160914_00192.jpg

11/15/2011 Debris on levee side of fence. This item was noted in the USACE PI.

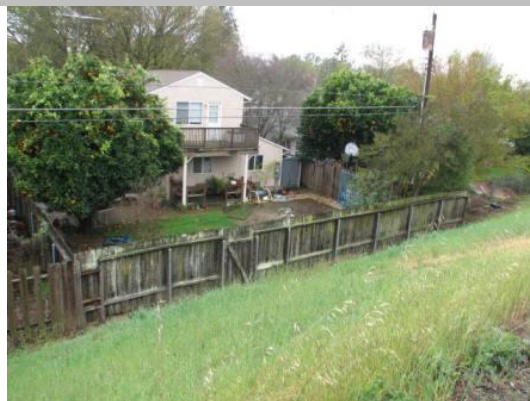
Photo 1 of 1 : FA_2016_NA0001_55_40_20160914_00033.jpg

LM Start	4.73	Rating **	U	Issue No.	40
LM End	4.73	Issue Type +	En	Location *	LS
Category	Earthen Levee			GPS Latitude/Longitude	
				Start	End
Item	Encroachments			38.580759 °	38.580759 °
				-121.434294 °	-121.434294 °
DWR ID	DWR_NA0001_04_s_2012_40				
Comment Code					
FE : Fence					
Inspector Comment					
Privacy fence within 10-ft of the levee toe obstruct access and visibility.

03/16/2012 Wood privacy fence completely obstructs access and visibility.

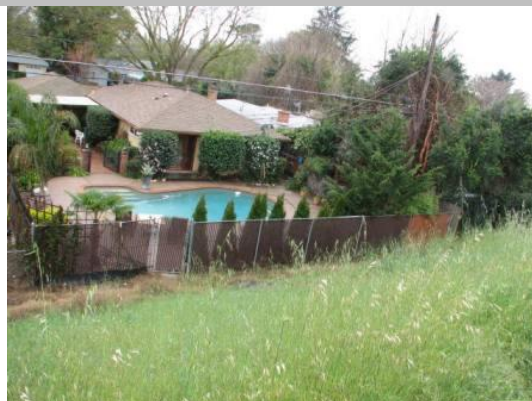
Photo 1 of 1 : FA_2016_NA0001_55_205_20160914_00172.jpg

LM Start	4.83	Rating **	U	Issue No.	205
LM End	4.83	Issue Type +	En	Location *	LS
Category	Earthen Levee			GPS Latitude/Longitude	
				Start	End
Item	Encroachments			38.580723 °	38.580723 °
				-121.432577 °	-121.432577 °
DWR ID	DWR_NA0001_04_s_2012_205				
Comment Code					
FE : Fence					
Inspector Comment					
Privacy fence and landscape prunings on levee slope and toe.prunings removed. Fence obstructs access and visibility.

03/16/2012 Chainlink fence with privacy slats obstructs visibility and access.

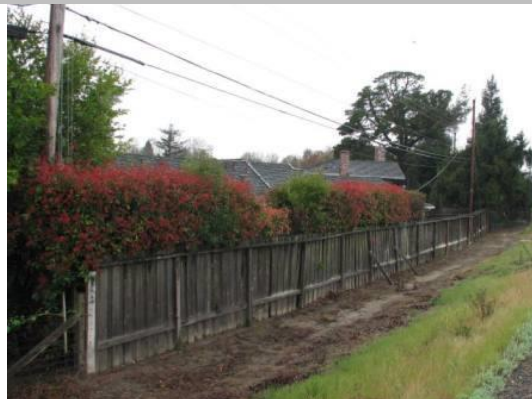
Photo 1 of 1 : FA_2016_NA0001_55_46_20160914_00037.jpg

LM Start	5.08	Rating **	U	Issue No.	46
LM End	5.08	Issue Type +	En	Location *	LS
Category	Earthen Levee			GPS Latitude/Longitude	
				Start	End
Item	Encroachments			38.581001 °	38.581001 °
				-121.427854 °	-121.427854 °
DWR ID	DWR_NA0001_04_s_2012_46				
Comment Code					
FE : Fence					
Inspector Comment					
Privacy fence and landscaping within 10-ft of the levee toe obstruct access and visibility.

03/16/2012 Wood privacy fence completely obstructs access and visibility.

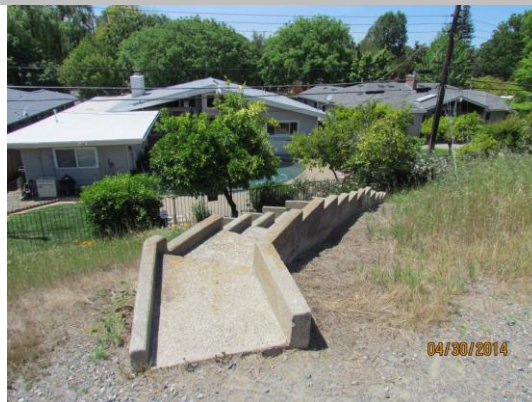
Photo 1 of 1 : FA_2016_NA0001_55_197_20160914_00167.jpg

LM Start	5.56	Rating **	U	Issue No.	197
LM End	5.56	Issue Type +	En	Location *	LS
Category	Earthen Levee			GPS Latitude/Longitude	
				Start	End
Item	Encroachments			38.575887 °	38.575887 °
				-121.423113 °	-121.423113 °
DWR ID	DWR_NA0001_04_s_2013_197				
Comment Code					
ST : Stairway					
Inspector Comment					
Unpermitted stairs to be removed by ARFCD.

View of the stairs on the landside levee slope.

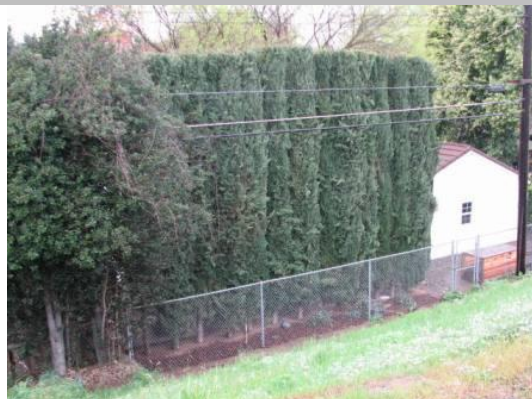
Photo 1 of 1 : FA_2016_NA0001_55_52_20160914_00042.jpg

LM Start	5.60	Rating **	U	Issue No.	52
LM End	5.60	Issue Type +	En	Location *	LS
Category	Earthen Levee			GPS Latitude/Longitude	
				Start	End
Item	Vegetation			38.575379 °	38.575379 °
				-121.423201 °	-121.423201 °
DWR ID	DWR_NA0001_04_s_2012_52				
Comment Code					
V6 : Landscaping					
Inspector Comment					
Helix sky pencil trees within 10-ft of the levee toe obstruct visibility and access.

03/16/2012 Landscaping obstructs visibility and access.

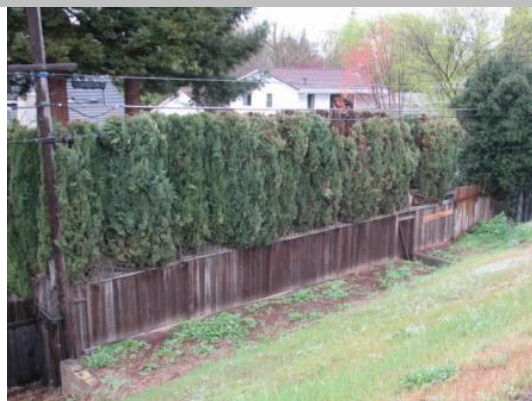
Photo 1 of 1 : FA_2016_NA0001_55_53_20160914_00043.jpg

LM Start	5.61	Rating **	U	Issue No.	53
LM End	5.61	Issue Type +	En	Location *	LS
Category	Earthen Levee			GPS Latitude/Longitude	
				Start	End
Item	Vegetation			38.575250 °	38.575250 °
				-121.423240 °	-121.423240 °
DWR ID	DWR_NA0001_04_s_2012_53				
Comment Code					
V6 : Landscaping					
Inspector Comment					
Wood privacy fence, helix sky pencil, vines and landscaping within 10-ft of the levee toe obstruct access and visibility. Cement stairs up levee slope.

03/16/2012 Landscaping and fence obstruct visibility and access.

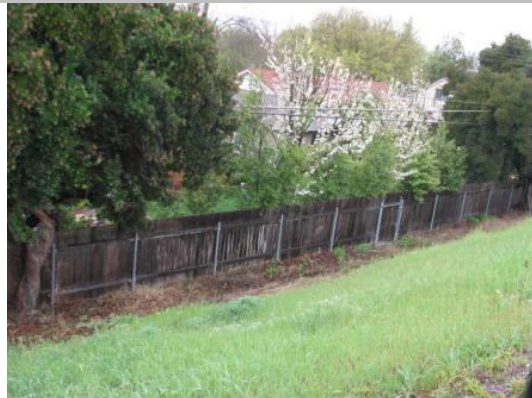
Photo 1 of 1 : FA_2016_NA0001_55_55_20160914_00045.jpg

LM Start	5.63	Rating **	U	Issue No.	55
LM End	5.63	Issue Type +	En	Location *	LS
Category	Earthen Levee			GPS Latitude/Longitude	
				Start	End
Item	Encroachments			38.574837 °	38.574837 °
				-121.423297 °	-121.423297 °
DWR ID	DWR_NA0001_04_s_2012_55				
Comment Code					
FE : Fence					
Inspector Comment					
Wood privacy fence within 10-ft of the levee toe obstructs visibility.

03/16/2012 Wood privacy fence completely obstructs access and visibility.

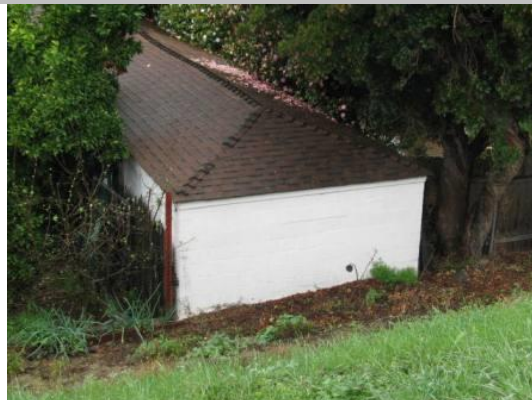
Photo 1 of 1 : FA_2016_NA0001_55_56_20160914_00046.jpg

LM Start	5.65	Rating **	U	Issue No.	56
LM End	5.65	Issue Type +	En	Location *	LS
Category	Earthen Levee			GPS Latitude/Longitude	
				Start	End
Item	Encroachments			38.574648 °	38.574648 °
				-121.423348 °	-121.423348 °
DWR ID	DWR_NA0001_04_s_2012_56				
Comment Code					
BU : Building					
Inspector Comment					
Cement block building on levee slope obstructs access.

03/16/2012 Structure within 15' of levee toe.

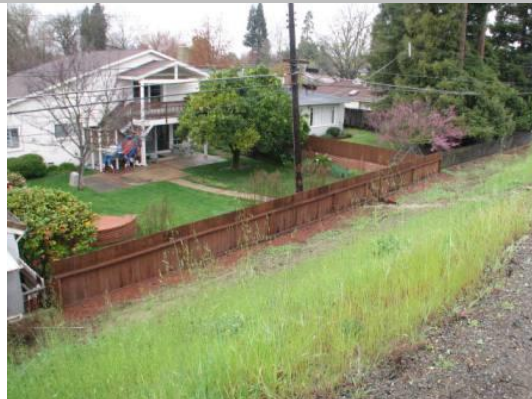
Photo 1 of 1 : FA_2016_NA0001_55_210_20160914_00175.jpg

LM Start	5.85	Rating **	U	Issue No.	210
LM End	5.85	Issue Type +	En	Location *	LS
Category	Earthen Levee			GPS Latitude/Longitude	
				Start	End
Item	Encroachments			38.571733 °	38.571733 °
				-121.424055 °	-121.424055 °
DWR ID	DWR_NA0001_04_s_2012_210				
Comment Code					
FE : Fence					
Inspector Comment					
Privacy fence and retaining wall are within 10-ft of levee toe.

03/16/2012 Wood privacy fence completely obstructs access and visibility.

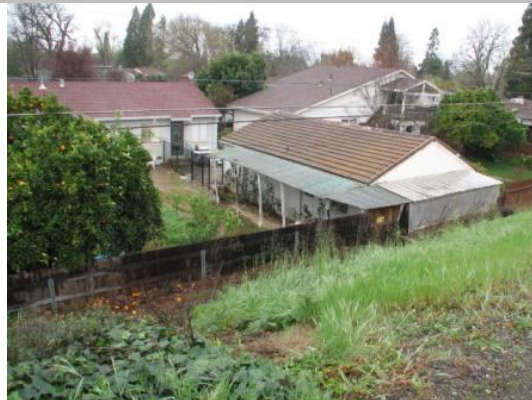
Photo 1 of 1 : FA_2016_NA0001_55_66_20160914_00052.jpg

LM Start	5.86	Rating **	U	Issue No.	66
LM End	5.86	Issue Type +	En	Location *	LS
Category	Earthen Levee			GPS Latitude/Longitude	
				Start	End
Item	Encroachments			38.571586 °	38.571586 °
				-121.424097 °	-121.424097 °
DWR ID	DWR_NA0001_04_s_2012_66				
Comment Code					
BU : Building					
Inspector Comment

03/16/2012 Structure is within 15' of levee toe.

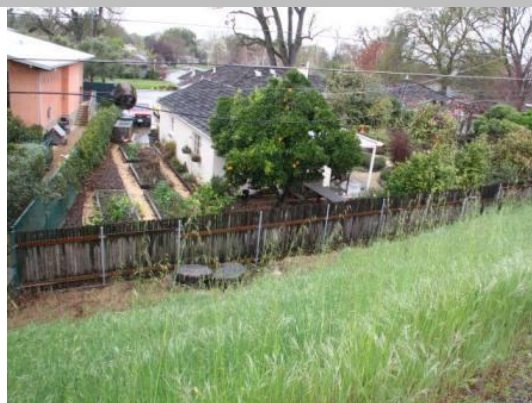
Photo 1 of 1 : FA_2016_NA0001_55_88_20160914_00072.jpg

LM Start	5.92	Rating **	U	Issue No.	88
LM End	5.92	Issue Type +	En	Location *	LS
Category	Earthen Levee			GPS Latitude/Longitude	
				Start	End
Item	Encroachments			38.570752 °	38.570752 °
				-121.424219 °	-121.424219 °
DWR ID	DWR_NA0001_04_f_2012_88				
Comment Code					
FE : Fence					
Inspector Comment					
Wooden privacy fence.

03/16/2012 Wood privacy fence completely obstructs access and visibility.

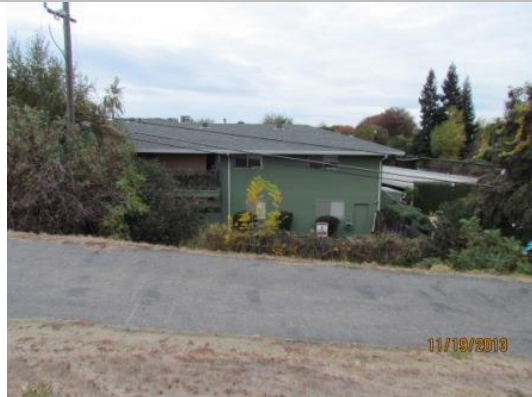
Photo 1 of 1 : FA_2016_NA0001_55_211_20160914_00176.jpg

LM Start	5.98	Rating **	M	Issue No.	211
LM End	5.98	Issue Type +	En	Location *	LS
Category	Earthen Levee			GPS Latitude/Longitude	
				Start	End
Item	Encroachments			38.569893 °	38.569893 °
				-121.424310 °	-121.424310 °
DWR ID	DWR_NA0001_04_s_2012_211				
Comment Code					
FE : Fence					
Inspector Comment					
Apartment complex privacy fence and shrubs within 10-ft of the slope obstruct visibility.

View of the fence at the landside levee toe.

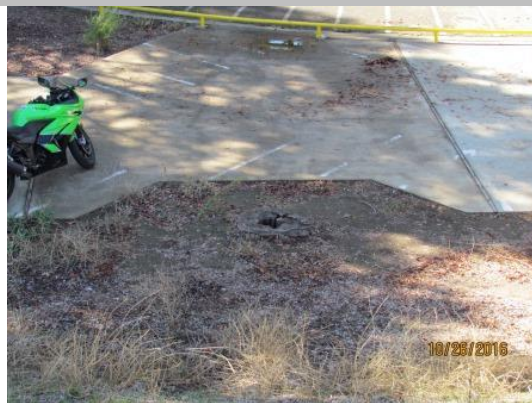
Photo 1 of 1 : FA_2016_NA0001_55_238_20161031_00248.jpg

LM Start	6.45	Rating **	N	Issue No.	238
LM End	6.45	Issue Type +	Ma	Location *	LS
Category	Earthen Levee			GPS Latitude/Longitude	
				Start	End
Item	Trim / Thin Trees			38.563231 °	38.563231 °
				-121.422404 °	-121.422404 °
DWR ID	DWR_NA0001_04_f_2015_238				
Comment Code					
T5 : Tree stumps.					
Inspector Comment

View of the tree stump at the landside levee toe.

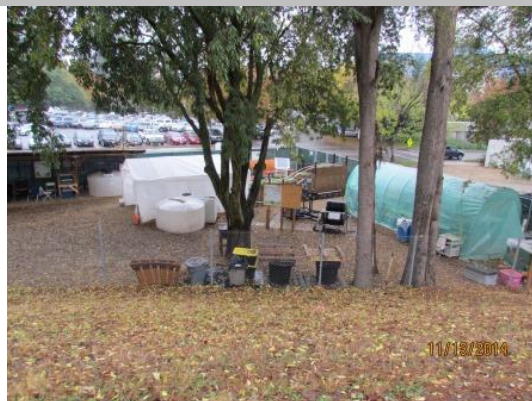
Photo 1 of 1 : FA_2016_NA0001_55_51_20160914_00041.jpg

LM Start	6.62	Rating **	M	Issue No.	51
LM End	6.62	Issue Type +	En	Location *	LS
Category	Earthen Levee			GPS Latitude/Longitude	
				Start	End
Item	Encroachments			38.561117 °	38.561117 °
				-121.420749 °	-121.420749 °
DWR ID	DWR_NA0001_04_f_2013_51				
Comment Code					
MA : Material					
Inspector Comment					
Pipe and other material stored within 10 feet of landside levee toe.

View of the material stored at the landside levee toe.

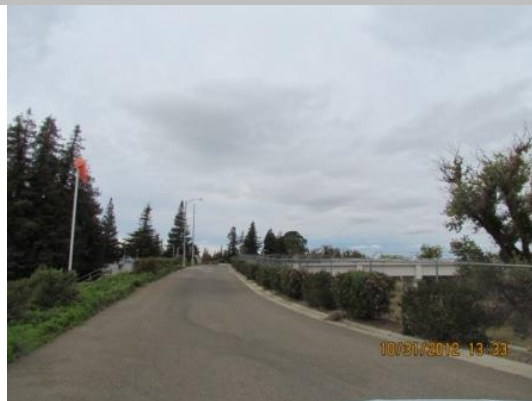
Photo 1 of 1 : FA_2016_NA0001_55_140_20160914_00119.jpg

LM Start	6.82	Rating **	M	Issue No.	140
LM End	6.94	Issue Type +	En	Location *	WS
Category	Earthen Levee			GPS Latitude/Longitude	
				Start	End
Item	Vegetation			38.559152 °	38.558115 °
				-121.418108 °	-121.416328 °
DWR ID	DWR_NA0001_04_f_2012_140				
Comment Code					
V6 : Landscaping					
Inspector Comment					
Bushes at waterside hinge obstruct visibility of waterside slope from levee crown.

View of landscaping at waterside hinge obstructing visibility.

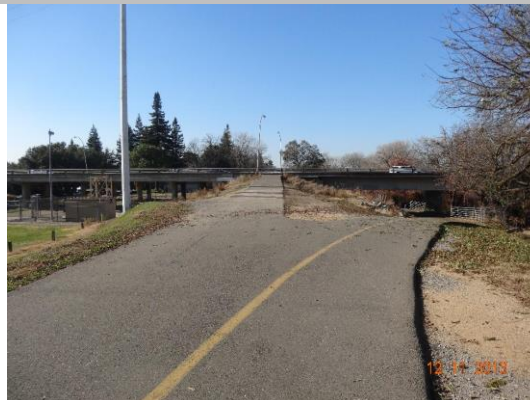
Photo 1 of 2 : UCIP_FA_2016_30023_55394.jpg

Comment Code					
Inspector Comment					
FS_ID:30023 DS_ID:24319 EP_NO: 3596 Repair Type: Non-Urgent Crossing Status: Indicator Found UCIP Comments: Need to contact owners to determine how crossing was abandoned. FIELD_STRUCT_DESC: *ABANDONED* [Power Inn Road Plant] 4 of 4: 48-inch corrugated metal (CM) drainpipe through the levee, 20.0 feet below the crown. Two CM cutoff walls around pipe under each shoulder. Slide gate with control pedestal in CM pipe riser on waterside (WS) slope. Slide gate with control pedestal in collection sump on landside (LS). Pumping plant at LS toe. Reinforced concrete discharge box at the toe of the WS slope. Flap gate on WS end. (Permit No. 3596-1962) 60-inch discharge pipe from box across the berm to the riverbank installed under Permit No. 5894 (1970). Pipe abandoned and CM pipe riser cut 2.0 feet below ground surface under Permit No. 3596A (1998). FS Date: 12/11/2013

Overview of levee crown at crossings.

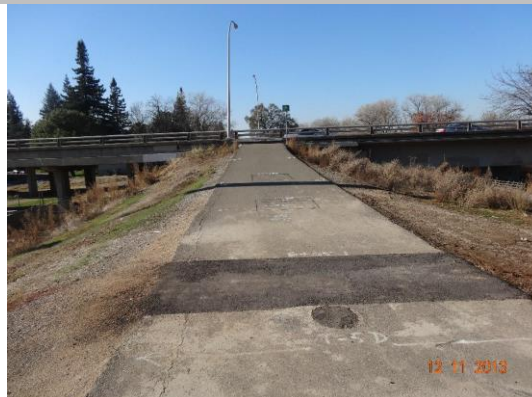
Photo 2 of 2 : UCIP_FA_2016_30023_55392.jpg

Item	DWR UCIP Field Study			38.558197°	38.558197°	
				-121.409106°	-121.409106°	
DWR ID						
Comment Code						
Inspector Comment						
FS_ID:30023 DS_ID:24319 EP_NO: 3596 Repair Type: Non-Urgent Crossing Status: Indicator Found UCIP Comments: Need to contact owners to determine how crossing was abandoned. FIELD_STRUCT_DESC: *ABANDONED* [Power Inn Road Plant] 4 of 4: 48-inch corrugated metal (CM) drainpipe through the levee, 20.0 feet below the crown. Two CM cutoff walls around pipe under each shoulder. Slide gate with control pedestal in CM pipe riser on waterside (WS) slope. Slide gate with control pedestal in collection sump on landside (LS). Pumping plant at LS toe. Reinforced concrete discharge box at the toe of the WS slope. Flap gate on WS end. (Permit No. 3596-1962) 60-inch discharge pipe from box across the berm to the riverbank installed under Permit No. 5894 (1970). Pipe abandoned and CM pipe riser cut 2.0 feet below ground surface under Permit No. 3596A (1998). FS Date: 12/11/2013

Signs of crossing repair patch section visible on levee crown.

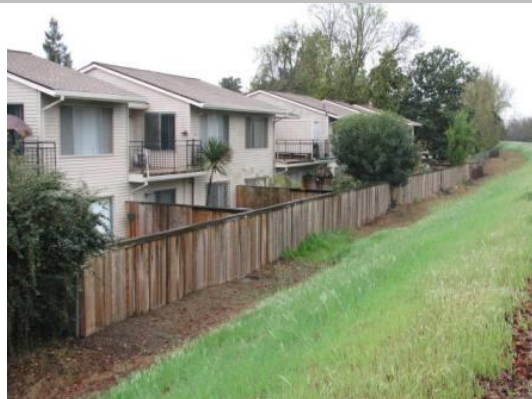
Photo 1 of 1 : FA_2016_NA0001_55_74_20160914_00058.jpg

LM Start	7.65	Rating **	U	Issue No.	74
LM End	7.68	Issue Type +	En	Location *	LS
Category	Earthen Levee			GPS Latitude/Longitude	
				Start	End
Item	Encroachments			38.559177 °	38.559218 °
				-121.403541 °	-121.402967 °
DWR ID	DWR_NA0001_04_s_2012_74				
Comment Code					
FE : Fence					
Inspector Comment					
Wooden privacy fence for seven apartment units is within 10-ft of levee toe and obstructs access and visibility.

03/16/2012 Wood privacy fence completely obstructs access and visibility.

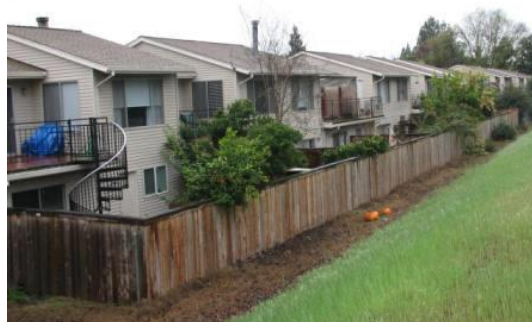
Photo 1 of 1 : FA_2016_NA0001_55_75_20160914_00059.jpg

LM Start	7.69	Rating **	U	Issue No.	75
LM End	7.72	Issue Type +	En	Location *	LS
Category	Earthen Levee			GPS Latitude/Longitude	
				Start	End
Item	Encroachments			38.559230 °	38.559261 °
				-121.402708 °	-121.402219 °
DWR ID	DWR_NA0001_04_s_2012_75				
Comment Code					
FE : Fence					
Inspector Comment					
Wooden privacy fence for seven apartment units is within 10-ft of levee toe and obstructs access and visibility.

03/16/2012 Wood privacy fence completely obstructs access and visibility.

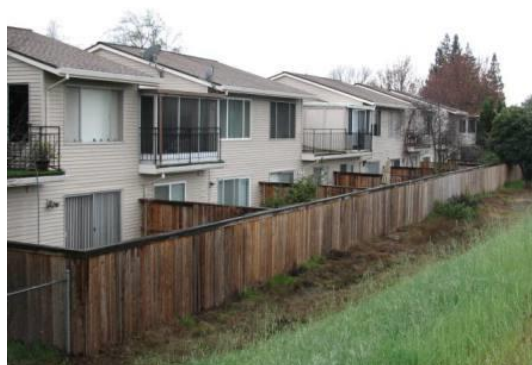
Photo 1 of 1 : FA_2016_NA0001_55_79_20160914_00063.jpg

LM Start	7.86	Rating **	U	Issue No.	79
LM End	7.88	Issue Type +	En	Location *	LS
Category	Earthen Levee			GPS Latitude/Longitude	
				Start	End
Item	Encroachments			38.559514 °	38.559643 °
				-121.399700 °	-121.399248 °
DWR ID	DWR_NA0001_04_s_2012_79				
Comment Code					
FE : Fence					
Inspector Comment					
Wooden privacy fence for seven apartment units is within 10-ft of levee toe and obstructs access and visibility.

03/16/2012 Wood privacy fence completely obstructs access and visibility.

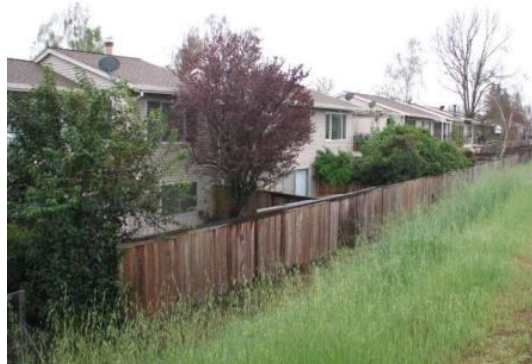
Photo 1 of 1 : FA_2016_NA0001_55_80_20160914_00064.jpg

LM Start	7.90	Rating **	U	Issue No.	80
LM End	7.93	Issue Type +	En	Location *	LS
Category	Earthen Levee			GPS Latitude/Longitude	
				Start	End
Item	Encroachments			38.559753 °	38.559911 °
				-121.398982 °	-121.398506 °
DWR ID	DWR_NA0001_04_s_2012_80				
Comment Code					
FE : Fence					
Inspector Comment					
Wooden privacy fence for seven apartment units is within 10-ft of levee toe and obstructs access and visibility.

03/16/2012 Wood privacy fence completely obstructs access and visibility.

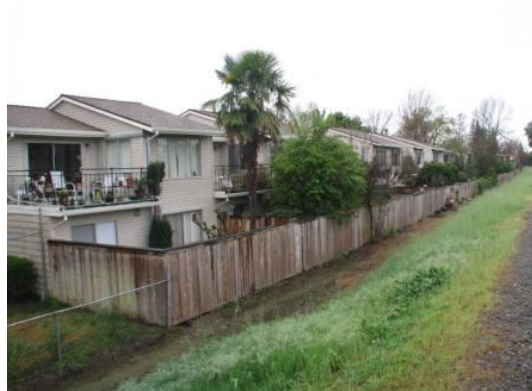
Photo 1 of 1 : FA_2016_NA0001_55_224_20160914_00177.jpg

LM Start	7.94	Rating **	U	Issue No.	224
LM End	7.97	Issue Type +	En	Location *	LS
Category	Earthen Levee			GPS Latitude/Longitude	
				Start	End
Item	Encroachments			38.559994 °	38.560185 °
				-121.398318 °	-121.397845 °
DWR ID	DWR_NA0001_04_s_2012_224				
Comment Code					
FE : Fence					
Inspector Comment					
Wooden privacy fence for seven apartment units is within 10-ft of levee toe and obstructs access and visibility.

03/16/2012 Wood privacy fence completely obstructs access and visibility.

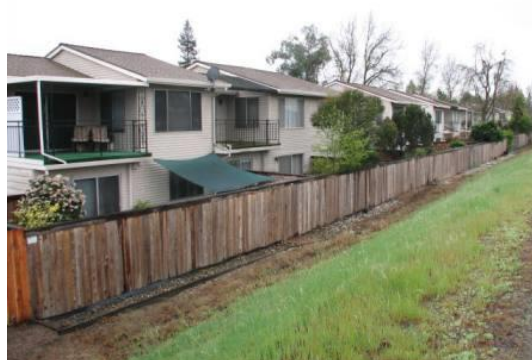
Photo 1 of 1 : FA_2016_NA0001_55_81_20160914_00065.jpg

LM Start	7.98	Rating **	U	Issue No.	81
LM End	8.00	Issue Type +	En	Location *	LS
Category	Earthen Levee			GPS Latitude/Longitude	
				Start	End
Item	Encroachments			38.560281 °	38.560435 °
				-121.397604 °	-121.397239 °
DWR ID	DWR_NA0001_04_s_2012_81				
Comment Code					
FE : Fence					
Inspector Comment					
Wooden privacy fence for seven apartment units is within 10-ft of levee toe and obstructs access and visibility.

03/16/2012 Wood privacy fence completely obstructs access and visibility.

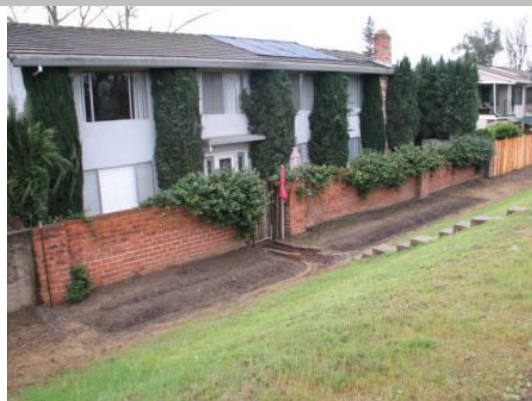
Photo 1 of 1 : FA_2016_NA0001_55_82_20160914_00066.jpg

LM Start	8.02	Rating **	U	Issue No.	82
LM End	8.02	Issue Type +	En	Location *	LS
Category	Earthen Levee			GPS Latitude/Longitude	
				Start	End
Item	Encroachments			38.560537 °	38.560537 °
				-121.396912 °	-121.396912 °
DWR ID	DWR_NA0001_04_s_2012_82				
Comment Code					
FE : Fence					
Inspector Comment					
Brick fence is within 10-ft of levee toe, obstructing access and visibility.

03/16/2012 Brick wall completely obstructs access and visibility.

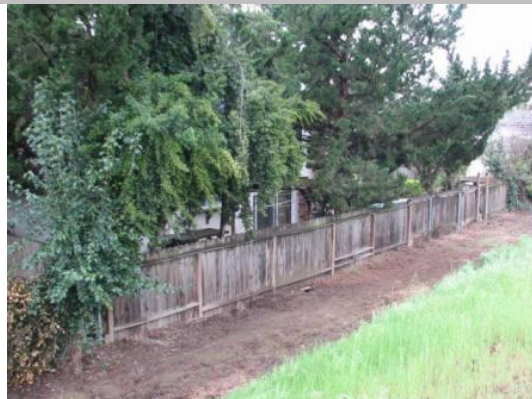
Photo 1 of 1 : FA_2016_NA0001_55_89_20160914_00073.jpg

LM Start	8.16	Rating **	U	Issue No.	89
LM End	8.16	Issue Type +	En	Location *	LS
Category	Earthen Levee			GPS Latitude/Longitude	
				Start	End
Item	Encroachments			38.561467 °	38.561467 °
				-121.394728 °	-121.394728 °
DWR ID	DWR_NA0001_04_s_2012_89				
Comment Code					
FE : Fence					
Inspector Comment					
Fence and landscaping arbor within 10-ft of levee toe obstructs access and visibility.

03/16/2012 Wood privacy fence completely obstructs access and visibility.

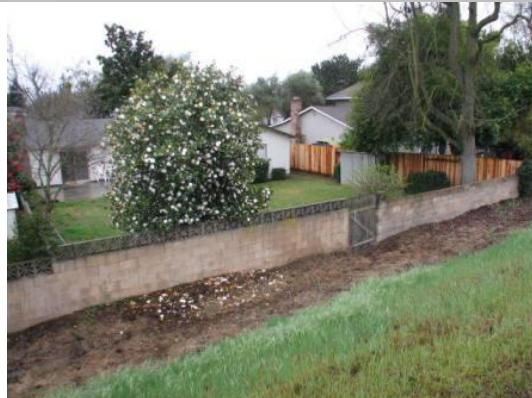
Photo 1 of 1 : FA_2016_NA0001_55_90_20160914_00074.jpg

LM Start	8.17	Rating **	U	Issue No.	90
LM End	8.17	Issue Type +	En	Location *	LS
Category	Earthen Levee			GPS Latitude/Longitude	
				Start	End
Item	Encroachments			38.561544 °	38.561544 °
				-121.394494 °	-121.394494 °
DWR ID	DWR_NA0001_04_s_2012_90				
Comment Code					
FE : Fence					
Inspector Comment					
Cement block fence within 10-ft of the levee toe.

03/16/2012 Cinder block wall completely obstructs access and visibility.

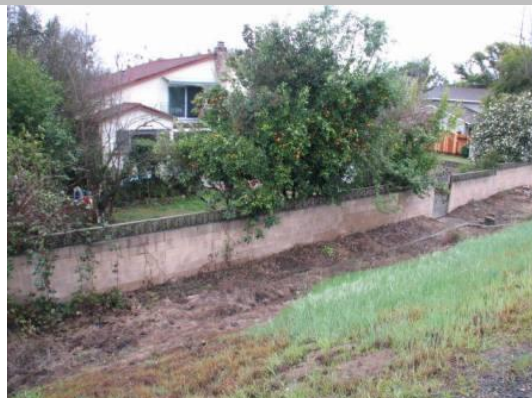
Photo 1 of 1 : FA_2016_NA0001_55_91_20160914_00075.jpg

LM Start	8.18	Rating **	U	Issue No.	91
LM End	8.18	Issue Type +	En	Location *	LS
Category	Earthen Levee			GPS Latitude/Longitude	
				Start	End
Item	Encroachments			38.561593 °	38.561593 °
				-121.394315 °	-121.394315 °
DWR ID	DWR_NA0001_04_s_2012_91				
Comment Code					
FE : Fence					
Inspector Comment					
Concrete block fence and landscaping within 10-ft of levee toe obstructs access and visibility.

03/16/2012 Cinder block wall completely obstructs access and visibility.

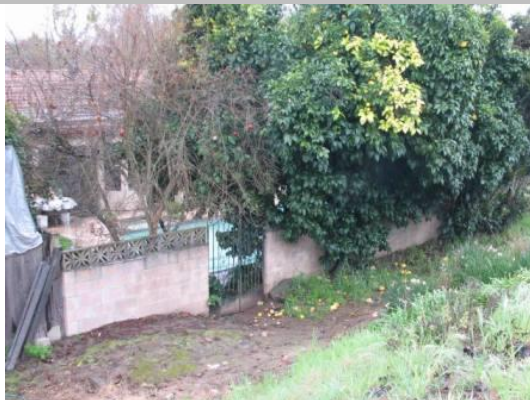
Photo 1 of 1 : FA_2016_NA0001_55_92_20160914_00076.jpg

LM Start	8.19	Rating **	U	Issue No.	92
LM End	8.19	Issue Type +	En	Location *	LS
Category	Earthen Levee			GPS Latitude/Longitude	
				Start	End
Item	Encroachments			38.561658 °	38.561658 °
				-121.394157 °	-121.394157 °
DWR ID	DWR_NA0001_04_s_2012_92				
Comment Code					
FE : Fence					
Inspector Comment					
Cement block fence and landscaping within 10-ft of levee toe obstructs access and visibility.

03/16/2012 Cinder block fence completely obstructs access and visibility.

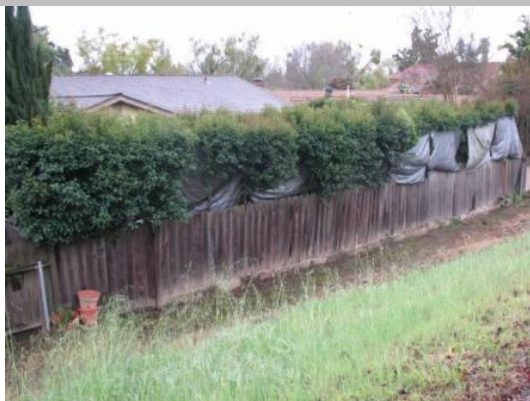
Photo 1 of 1 : FA_2016_NA0001_55_93_20160914_00077.jpg

LM Start	8.21	Rating **	U	Issue No.	93	
LM End	8.21	Issue Type +	En	Location *	LS	
Category	Earthen Levee			GPS Latitude/Longitude		
				Start	End	
Item	Encroachments			38.561750 °	38.561750 °	
				-121.393917 °	-121.393917 °	
DWR ID	DWR_NA0001_04_s_2012_93					
Comment Code						
FE : Fence						
Inspector Comment						
Wooden fence, strung tarps, and landscaping within 10-ft of levee toe obstructs access and visibility.

03/16/2012 Wood privacy fence completely obstructs access and visibility.

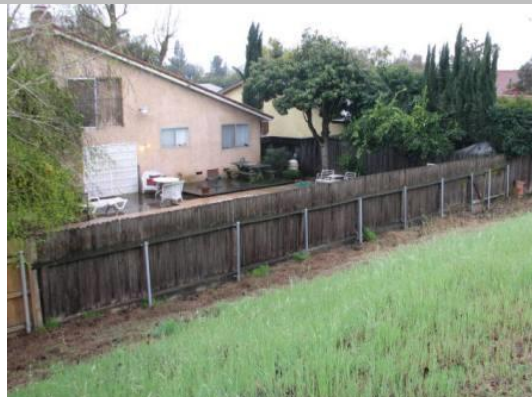
Photo 1 of 1 : FA_2016_NA0001_55_94_20160914_00078.jpg

LM Start	8.21	Rating **	U	Issue No.	94
LM End	8.21	Issue Type +	En	Location *	LS
Category	Earthen Levee			GPS Latitude/Longitude	
				Start	End
Item	Encroachments			38.561799 °	38.561799 °
				-121.393758 °	-121.393758 °
DWR ID	DWR_NA0001_04_s_2012_94				
Comment Code					
FE : Fence					
Inspector Comment					
Wood privacy fence and pool within 10-ft of levee toe obstructs access and visibility.

03/16/2012 Wood privacy fence completely obstructs access and visibility.

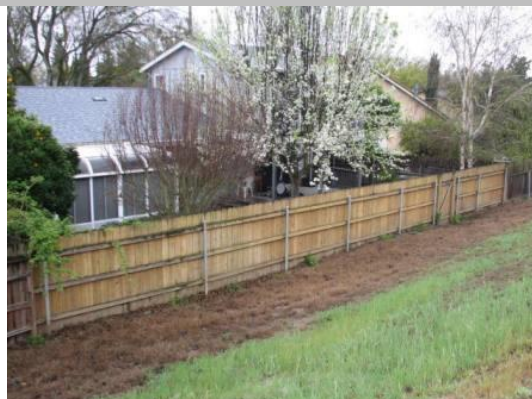
Photo 1 of 1 : FA_2016_NA0001_55_95_20160914_00079.jpg

LM Start	8.23	Rating **	U	Issue No.	95
LM End	8.23	Issue Type +	En	Location *	LS
Category	Earthen Levee			GPS Latitude/Longitude	
				Start	End
Item	Encroachments			38.561900 °	38.561900 °
				-121.393547 °	-121.393547 °
DWR ID	DWR_NA0001_04_s_2012_95				
Comment Code					
FE : Fence					
Inspector Comment					
Wood privacy fence within 10-ft of levee toe obstructs access and visibility.

03/16/2012 Wood privacy fence completely obstructs access and visibility.

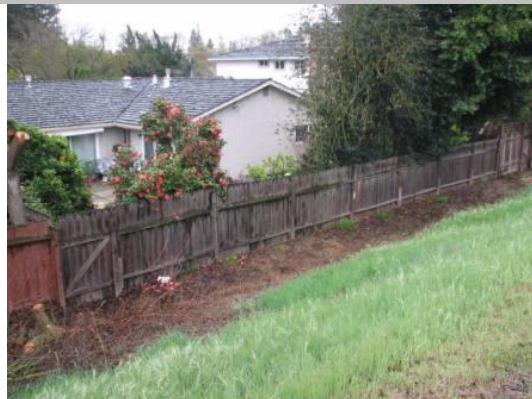
Photo 1 of 1 : FA_2016_NA0001_55_99_20160914_00083.jpg

LM Start	8.26	Rating **	U	Issue No.	99
LM End	8.26	Issue Type +	En	Location *	LS
Category	Earthen Levee			GPS Latitude/Longitude	
				Start	End
Item	Encroachments			38.562120 °	38.562120 °
				-121.392983 °	-121.392983 °
DWR ID	DWR_NA0001_04_s_ 2012_99				
Comment Code					
FE : Fence					
Inspector Comment					
Wood privacy fence within 10-ft of levee toe obstructs access and visibility.

03/16/2012 Wood privacy fence completely obstructs access and visibility.

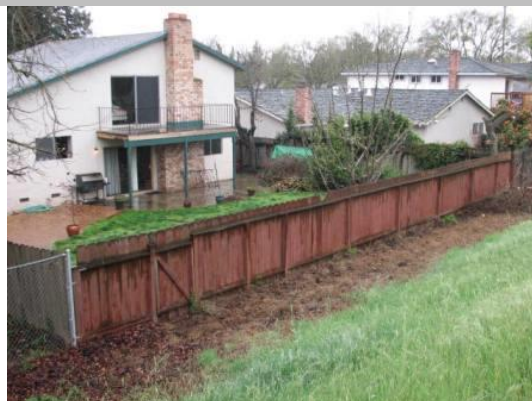
Photo 1 of 1 : FA_2016_NA0001_55_100_20160914_00084.jpg

LM Start	8.27	Rating **	U	Issue No.	100
LM End	8.27	Issue Type +	En	Location *	LS
Category	Earthen Levee			GPS Latitude/Longitude	
				Start	End
Item	Encroachments			38.562182 °	38.562182 °
				-121.392778 °	-121.392778 °
DWR ID	DWR_NA0001_04_s_ 2012_100				
Comment Code					
FE : Fence					
Inspector Comment					
Wood privacy fence within 10-ft of levee toe obstructs access and visibility.

03/16/2012 Wood privacy fence completely obstructs access and visibility.

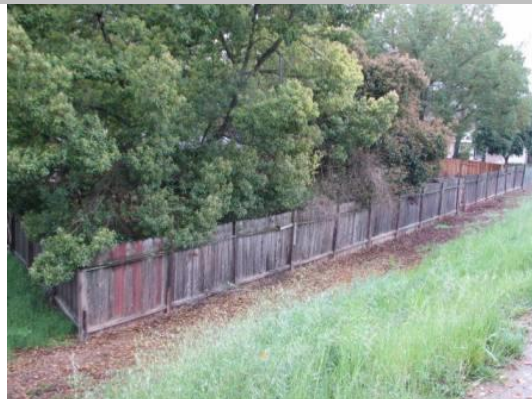
Photo 1 of 1 : FA_2016_NA0001_55_101_20160914_00085.jpg

LM Start	8.32	Rating **	U	Issue No.	101
LM End	8.32	Issue Type +	En	Location *	LS
Category	Earthen Levee			GPS Latitude/Longitude	
				Start	End
Item	Encroachments			38.562508 °	38.562508 °
				-121.392037 °	-121.392037 °
DWR ID	DWR_NA0001_04_s_2012_101				
Comment Code					
FE : Fence					
Inspector Comment					
Wood privacy fence within 10-ft of levee toe obstructs access and visibility.

03/16/2012 Wood privacy fence completely obstructs access and visibility.

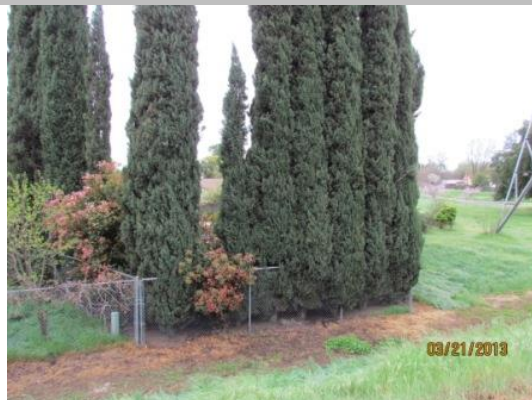
Photo 1 of 1 : FA_2016_NA0001_55_102_20160914_00086.jpg

LM Start	8.38	Rating **	M	Issue No.	102
LM End	8.38	Issue Type +	En	Location *	LS
Category	Earthen Levee			GPS Latitude/Longitude	
				Start	End
Item	Vegetation			38.562889 °	38.562889 °
				-121.391042 °	-121.391042 °
DWR ID	DWR_NA0001_04_s_2012_102				
Comment Code					
V6 : Landscaping					
Inspector Comment					
Helix sky pencil along chain link fence is within 10-ft of the levee toe.

View of the landscaping at the levee toe.

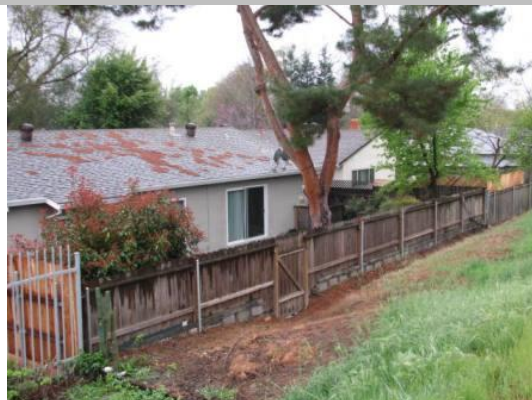
Photo 1 of 1 : FA_2016_NA0001_55_110_20160914_00094.jpg

LM Start	8.51	Rating **	U	Issue No.	110
LM End	8.51	Issue Type +	En	Location *	LS
Category	Earthen Levee			GPS Latitude/Longitude	
				Start	End
Item	Encroachments			38.563732 °	38.563732 °
				-121.388930 °	-121.388930 °
DWR ID	DWR_NA0001_04_s_2012_110				
Comment Code					
FE : Fence					
Inspector Comment					
Wood privacy fence within 10-ft of levee toe obstructs access and visibility.

03/16/2012 Wood privacy fence completely obstructs access and visibility.

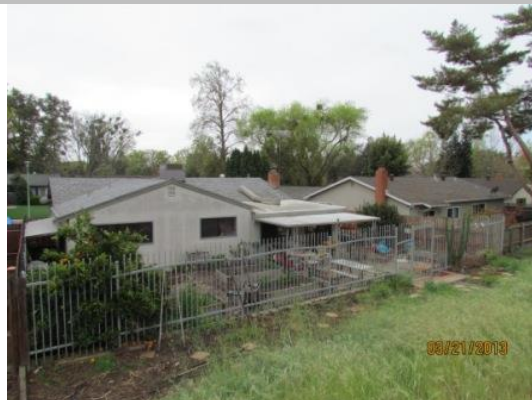
Photo 1 of 1 : FA_2016_NA0001_55_226_20160914_00179.jpg

LM Start	8.52	Rating **	M	Issue No.	226
LM End	8.52	Issue Type +	En	Location *	LS
Category	Earthen Levee			GPS Latitude/Longitude	
				Start	End
Item	Vegetation			38.563793 °	38.563793 °
				-121.388758 °	-121.388758 °
DWR ID	DWR_NA0001_04_s_2012_226				
Comment Code					
V6 : Landscaping					
Inspector Comment					
Garden, trees and cactus planted against the levee toe.

View of landscaping at the levee toe.

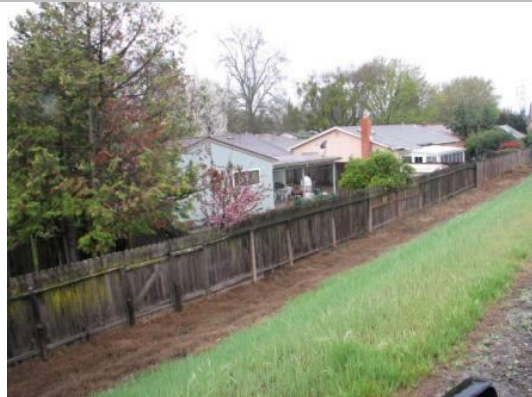
Photo 1 of 1 : FA_2016_NA0001_55_118_20160914_00102.jpg

LM Start	8.61	Rating **	U	Issue No.	118
LM End	8.61	Issue Type +	En	Location *	LS
Category	Earthen Levee			GPS Latitude/Longitude	
				Start	End
Item	Encroachments			38.564133 °	38.564133 °
				-121.387092 °	-121.387092 °
DWR ID	DWR_NA0001_04_s_2012_118				
Comment Code					
FE : Fence					
Inspector Comment					
Wood privacy fence within 10-ft of levee toe obstructs access and visibility.

03/16/2012 Wood privacy fence completely obstructs access and visibility.

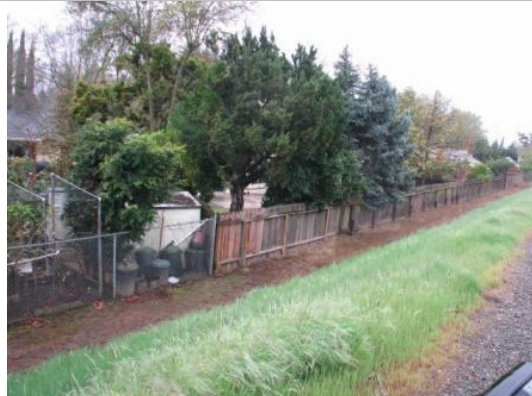
Photo 1 of 1 : FA_2016_NA0001_55_119_20160914_00103.jpg

LM Start	8.63	Rating **	U	Issue No.	119
LM End	8.63	Issue Type +	En	Location *	LS
Category	Earthen Levee			GPS Latitude/Longitude	
				Start	End
Item	Encroachments			38.564217 °	38.564217 °
				-121.386846 °	-121.386846 °
DWR ID	DWR_NA0001_04_s_2012_119				
Comment Code					
FE : Fence					
Inspector Comment					
Wood privacy fence within 10-ft of levee toe obstructs access and visibility.

03/16/2012 Wood privacy fence completely obstructs access and visibility.

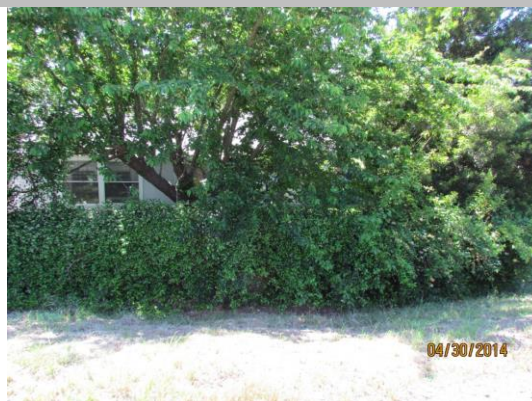
Photo 1 of 1 : FA_2016_NA0001_55_236_20160914_00184.jpg

LM Start	9.48	Rating **	M	Issue No.	236
LM End	9.48	Issue Type +	En	Location *	LS
Category	Earthen Levee			GPS Latitude/Longitude	
				Start	End
Item	Vegetation			38.566948 °	38.566948 °
				-121.371562 °	-121.371562 °
DWR ID	DWR_NA0001_04_s_2012_236				
Comment Code					
V6 : Landscaping					
Inspector Comment					
Landscaping within 10-ft of levee toe.

View of the landscaping at the landside levee to obstructing visibility and access.

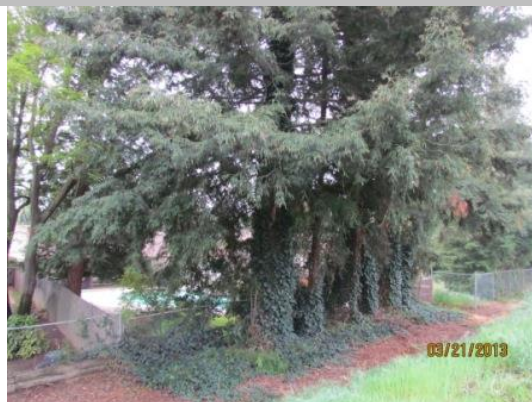
Photo 1 of 1 : FA_2016_NA0001_55_237_20160914_00185.jpg

LM Start	9.48	Rating **	M	Issue No.	237
LM End	9.48	Issue Type +	En	Location *	LS
Category	Earthen Levee			GPS Latitude/Longitude	
				Start	End
Item	Vegetation			38.566938 °	38.566938 °
				-121.371550 °	-121.371550 °
DWR ID	DWR_NA0001_04_s_2012_237				
Comment Code					
V6 : Landscaping					
Inspector Comment					
Redwoods and ivy along fence within 10-ft of levee toe.

View of landscaping at levee toe.

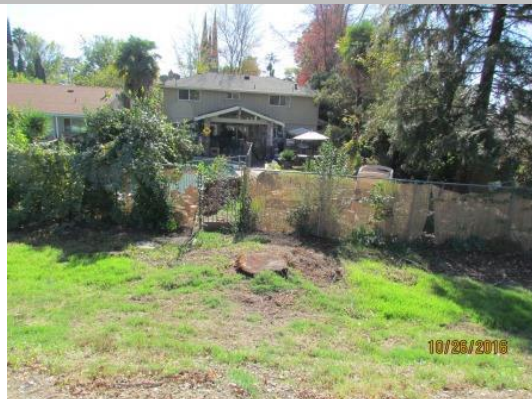
Photo 1 of 1 : FA_2016_NA0001_55_222_20161031_00245.jpg

LM Start	9.81	Rating **	N	Issue No.	222
LM End	9.81	Issue Type +	Ma	Location *	LS
Category	Earthen Levee			GPS Latitude/Longitude	
				Start	End
Item	Trim / Thin Trees			38.568114 °	38.568114 °
				-121.365747 °	-121.365747 °
DWR ID	DWR_NA0001_04_f_2016_222				
Comment Code					
T5 : Tree stumps.					
Inspector Comment

View of the tree stump at the landside levee toe.

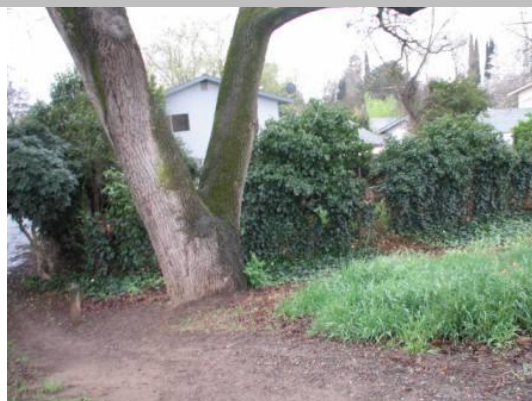
Photo 1 of 1 : FA_2016_NA0001_55_135_20160914_00116.jpg

LM Start	9.89	Rating **	U	Issue No.	135
LM End	9.89	Issue Type +	En	Location *	LS
Category	Earthen Levee			GPS Latitude/Longitude	
				Start	End
Item	Vegetation			38.568446 °	38.568446 °
				-121.364385 °	-121.364385 °
DWR ID	DWR_NA0001_04_s_2012_135				
Comment Code					
V6 : Landscaping					
Inspector Comment					
Tall hedge and ivy within 10-ft of landside levee toe.

03/16/2012 Landscaping is obstructing visibility.

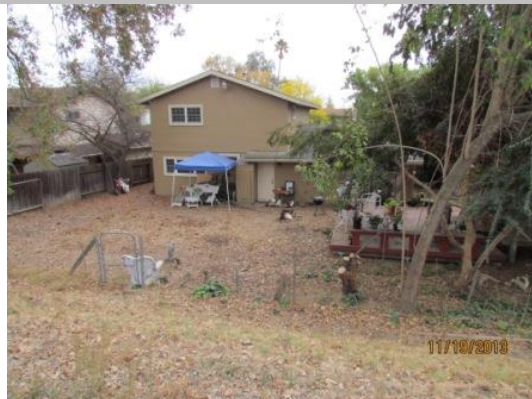
Photo 1 of 1 : FA_2016_NA0001_55_136_20160914_00117.jpg

LM Start	9.95	Rating **	M	Issue No.	136
LM End	9.95	Issue Type +	En	Location *	LS
Category	Earthen Levee			GPS Latitude/Longitude	
				Start	End
Item	Encroachments			38.568714 °	38.568714 °
				-121.363257 °	-121.363257 °
DWR ID	DWR_NA0001_04_s_2012_136				
Comment Code					
FE : Fence					
Inspector Comment					
Wire fence within 10-ft of landside levee toe.

View of the fence and tree stump at the landside levee toe.

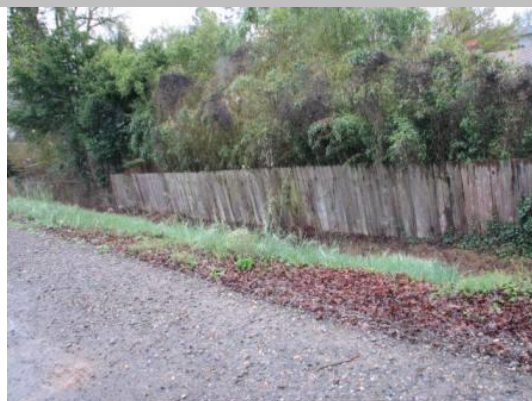
Photo 1 of 1 : FA_2016_NA0001_55_138_20160914_00118.jpg

LM Start	10.00	Rating **	U	Issue No.	138
LM End	10.00	Issue Type +	En	Location *	LS
Category	Earthen Levee			GPS Latitude/Longitude	
				Start	End
Item	Encroachments			38.568953 °	38.568953 °
				-121.362396 °	-121.362396 °
DWR ID	DWR_NA0001_04_s_2012_138				
Comment Code					
FE : Fence					
Inspector Comment					
03/16/2012 Wood privacy fence completely obstructs visibility and access.

03/16/2012 Wood privacy fence completely obstructs access and visibility.

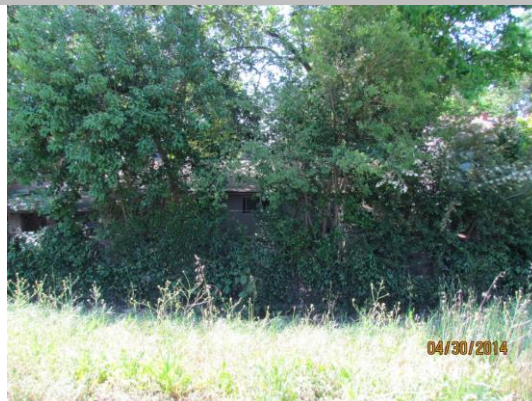
Photo 1 of 1 : FA_2016_NA0001_55_245_20160914_00189.jpg

LM Start	10.06	Rating **	U	Issue No.	245
LM End	10.06	Issue Type +	En	Location *	LS
Category	Earthen Levee			GPS Latitude/Longitude	
				Start	End
Item	Encroachments			38.569247 °	38.569247 °
				-121.361315 °	-121.361315 °
DWR ID	DWR_NA0001_04_s_2014_245				
Comment Code					
FE : Fence					
Inspector Comment					
Rod fence covered with vegetation within 10ft of levee toe.

View of the fence at the landside levee toe.

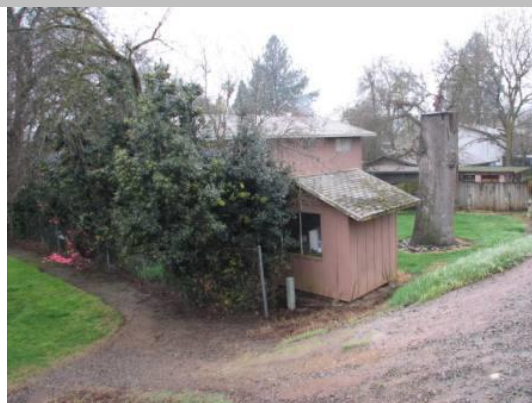
Photo 1 of 1 : FA_2016_NA0001_55_176_20160914_00153.jpg

LM Start	10.08	Rating **	U	Issue No.	176
LM End	10.08	Issue Type +	En	Location *	LS
Category	Earthen Levee			GPS Latitude/Longitude	
				Start	End
Item	Encroachments			38.569293 °	38.569293 °
				-121.361002 °	-121.361002 °
DWR ID	DWR_NA0001_04_s_2012_176				
Comment Code					
BU : Building					
Inspector Comment

03/16/2012 Wood structure within 15' of levee toe.

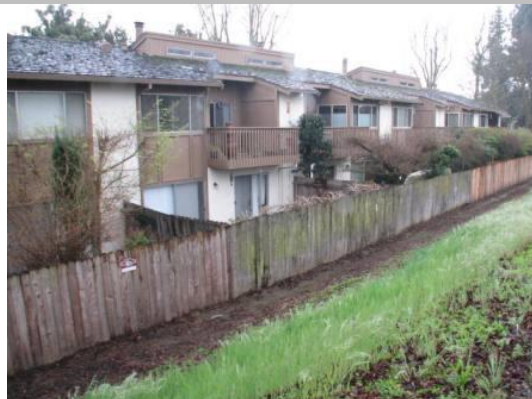
Photo 1 of 1 : FA_2016_NA0001_55_141_20160914_00120.jpg

LM Start	10.24	Rating **	U	Issue No.	141
LM End	10.27	Issue Type +	En	Location *	LS
Category	Earthen Levee			GPS Latitude/Longitude	
				Start	End
Item	Encroachments			38.569982 °	38.570118 °
				-121.358134 °	-121.357604 °
DWR ID	DWR_NA0001_04_s_2012_141				
Comment Code					
FE : Fence					
Inspector Comment					
Wooden fence behind six apartment units is within 10-ft of levee slope.

03/16/2012 Wood privacy fence completely obstructs access and visibility.

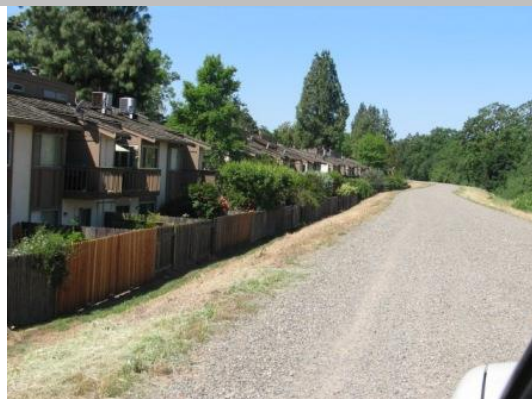
Photo 1 of 1 : FA_2016_NA0001_55_142_20160914_00121.jpg

LM Start	10.28	Rating **	U	Issue No.	142
LM End	10.30	Issue Type +	En	Location *	LS
Category	Earthen Levee			GPS Latitude/Longitude	
				Start	End
Item	Encroachments			38.570175 °	38.570229 °
				-121.357390 °	-121.357041 °
DWR ID	DWR_NA0001_04_s_2012_142				
Comment Code					
FE : Fence					
Inspector Comment					
Wooden fence behind six apartment units is within 10-ft of levee slope.

Wooden fence behind apartments within 10' of levee toe.

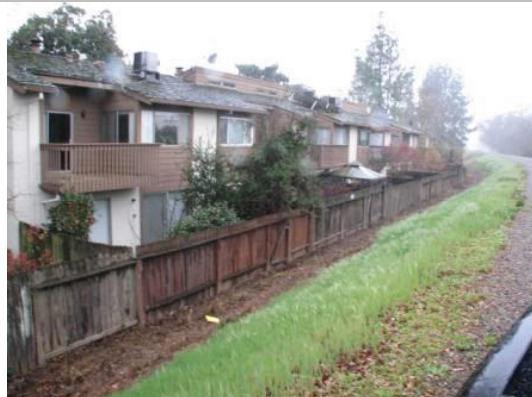
Photo 1 of 1 : FA_2016_NA0001_55_146_20160914_00125.jpg

LM Start	10.30	Rating **	U	Issue No.	146
LM End	10.32	Issue Type +	En	Location *	LS
Category	Earthen Levee			GPS Latitude/Longitude	
				Start	End
Item	Encroachments			38.570225 °	38.570245 °
				-121.357014 °	-121.356791 °
DWR ID	DWR_NA0001_04_s_2012_146				
Comment Code					
FE : Fence					
Inspector Comment					
Wooden fence behind 6 apartments.

03/16/2012 Wood privacy fence completely obstructs access and visibility.

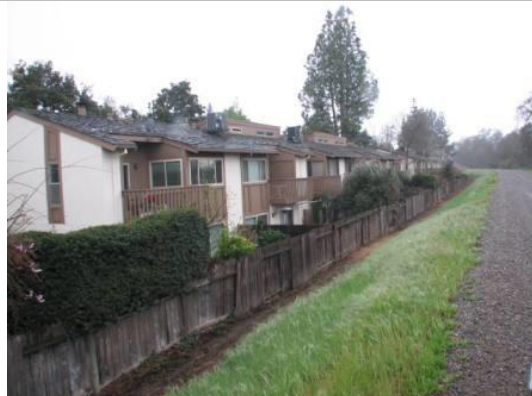
Photo 1 of 1 : FA_2016_NA0001_55_143_20160914_00122.jpg

LM Start	10.32	Rating **	U	Issue No.	143
LM End	10.34	Issue Type +	En	Location *	LS
Category	Earthen Levee			GPS Latitude/Longitude	
				Start	End
Item	Encroachments			38.570257 °	38.570297 °
				-121.356783 °	-121.356403 °
DWR ID	DWR_NA0001_04_s_2012_143				
Comment Code					
FE : Fence					
Inspector Comment					
Wooden fence behind six apartment units is within 10-ft of levee slope.

03/16/2012 Wood privacy fence completely obstructs access and visibility.

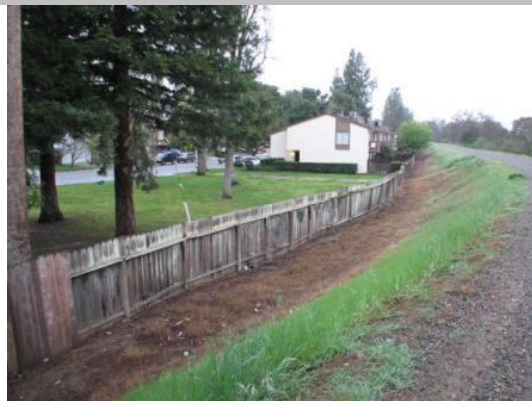
Photo 1 of 1 : FA_2016_NA0001_55_147_20160914_00126.jpg

LM Start	10.43	Rating **	U	Issue No.	147
LM End	10.43	Issue Type +	En	Location *	LS
Category	Earthen Levee			GPS Latitude/Longitude	
				Start	End
Item	Encroachments			38.570542 °	38.570542 °
				-121.354772 °	-121.354772 °
DWR ID	DWR_NA0001_04_s_2012_147				
Comment Code					
FE : Fence					
Inspector Comment					
Wooden privacy fence.

03/16/2012 Wood privacy fence completely obstructs access and visibility.

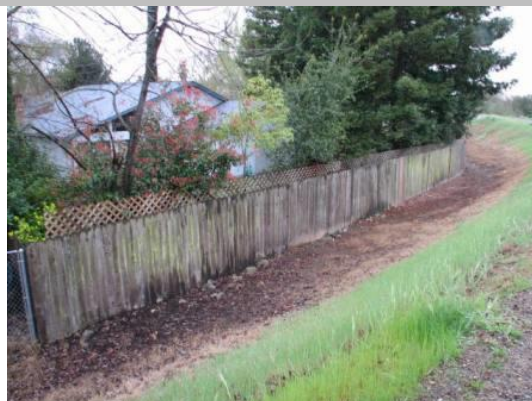
Photo 1 of 1 : FA_2016_NA0001_55_148_20160914_00127.jpg

LM Start	10.45	Rating **	U	Issue No.	148
LM End	10.45	Issue Type +	En	Location *	LS
Category	Earthen Levee			GPS Latitude/Longitude	
				Start	End
Item	Encroachments			38.570524 °	38.570524 °
				-121.354359 °	-121.354359 °
DWR ID	DWR_NA0001_04_s_2012_148				
Comment Code					
FE : Fence					
Inspector Comment					
Wooden privacy fence obstructs visibility and access.

03/16/2012 Wood privacy fence completely obstructs access and visibility.

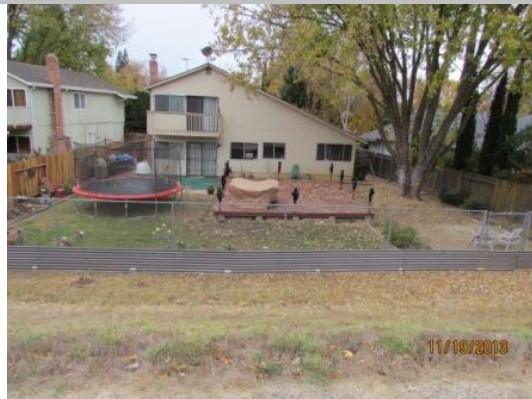
Photo 1 of 1 : FA_2016_NA0001_55_180_20160914_00157.jpg

LM Start	10.47	Rating **	M	Issue No.	180
LM End	10.47	Issue Type +	En	Location *	LS
Category	Earthen Levee			GPS Latitude/Longitude	
				Start	End
Item	Encroachments			38.570397 °	38.570397 °
				-121.354084 °	-121.354084 °
DWR ID	DWR_NA0001_04_s_2012_180				
Comment Code					
FE : Fence					
Inspector Comment					
Chainlink fence partially obstructs, currently visibility is unobstructed.

Chainlink fence is partially obstructing visibility and access.

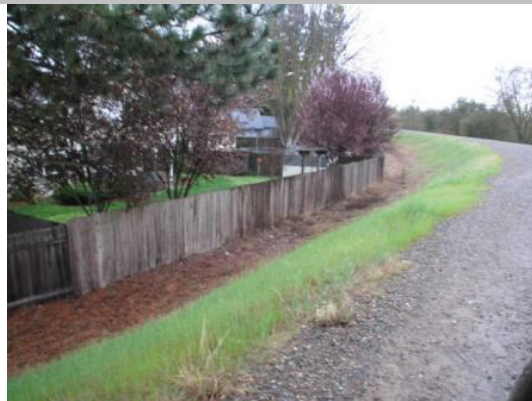
Photo 1 of 1 : FA_2016_NA0001_55_149_20160914_00128.jpg

LM Start	10.48	Rating **	U	Issue No.	149
LM End	10.48	Issue Type +	En	Location *	LS
Category	Earthen Levee			GPS Latitude/Longitude	
				Start	End
Item	Encroachments			38.570234 °	38.570234 °
				-121.353862 °	-121.353862 °
DWR ID	DWR_NA0001_04_s_2012_149				
Comment Code					
FE : Fence					
Inspector Comment					
Wooden privacy fence is within 10-ft of levee toe.

03/16/2012 Wood privacy fence completely obstructs access and visibility.

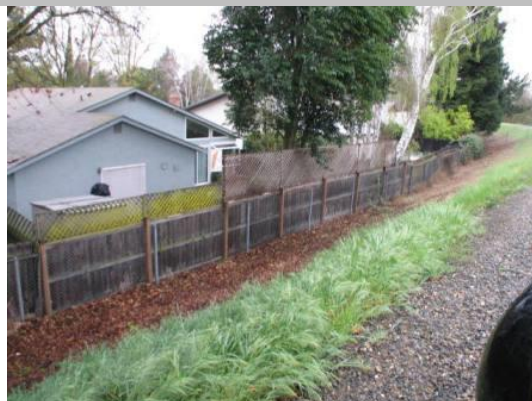
Photo 1 of 1 : FA_2016_NA0001_55_152_20160914_00131.jpg

LM Start	10.52	Rating **	U	Issue No.	152
LM End	10.52	Issue Type +	En	Location *	LS
Category	Earthen Levee			GPS Latitude/Longitude	
				Start	End
Item	Encroachments			38.569758 °	38.569758 °
				-121.353535 °	-121.353535 °
DWR ID	DWR_NA0001_04_s_2012_152				
Comment Code					
FE : Fence					
Inspector Comment					
Wooden privacy fence within 10-ft of levee toe.

03/16/2012 Wood privacy fence completely obstructs access and visibility.

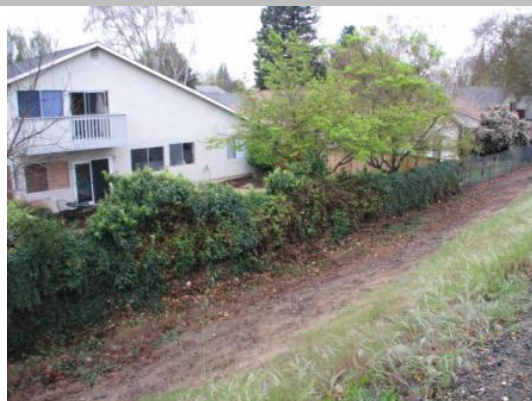
Photo 1 of 1 : FA_2016_NA0001_55_153_20160914_00132.jpg

LM Start	10.57	Rating **	U	Issue No.	153
LM End	10.57	Issue Type +	En	Location *	LS
Category	Earthen Levee			GPS Latitude/Longitude	
				Start	End
Item	Encroachments			38.569166 °	38.569166 °
				-121.353272 °	-121.353272 °
DWR ID	DWR_NA0001_04_s_2012_153				
Comment Code					
FE : Fence					
Inspector Comment					
Wooden privacy fence and ivy within 10-ft of levee toe.

03/16/2012 Wood privacy fence completely obstructs access and visibility.

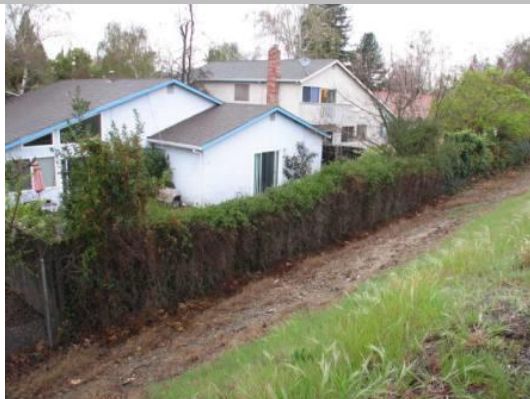
Photo 1 of 1 : FA_2016_NA0001_55_154_20160914_00133.jpg

LM Start	10.57	Rating **	U	Issue No.	154
LM End	10.57	Issue Type +	En	Location *	LS
Category	Earthen Levee			GPS Latitude/Longitude	
				Start	End
Item	Encroachments			38.569020 °	38.569020 °
				-121.353313 °	-121.353313 °
DWR ID	DWR_NA0001_04_s_2012_154				
Comment Code					
FE : Fence					
Inspector Comment					
Wooden privacy fence within 10-ft of levee toe.

03/16/2012 Wood privacy fence completely obstructs access and visibility.
